# **HYDRODYNAMIC AIR LUBRICATED COMPLIANT SURFACE BEARING FOR AN AUTOMOTIVE GAS TURBINE ENGINE II - MATERIALS AND COATINGS**

Bharat Bhushan, David Ruscitto, and Stanley Gray  
Mechanical Technology Incorporated  
Latham, New York 12110

**July 1978**

Contract NAS 3-19427

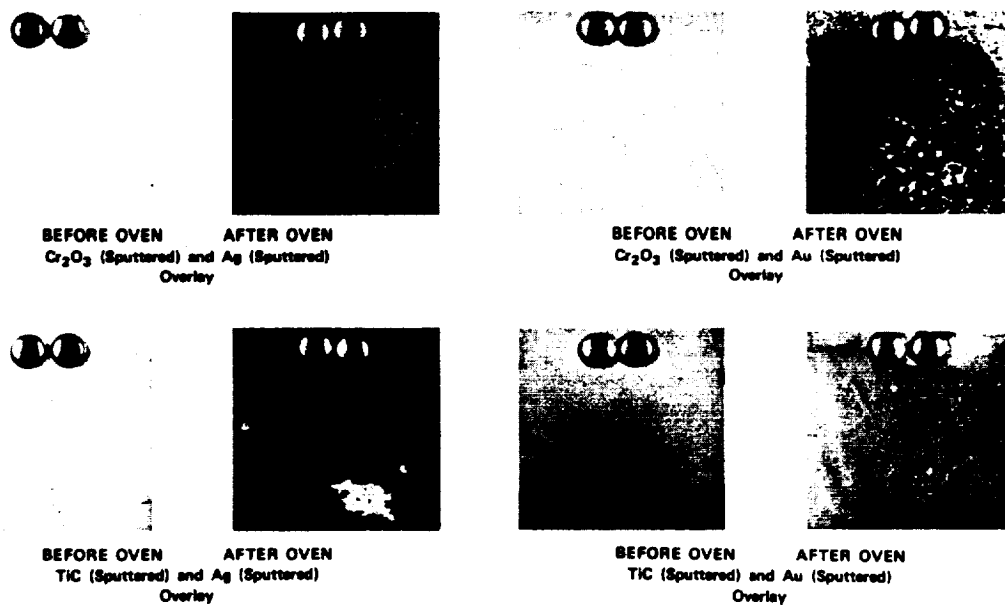
Fig. III.7 Photograph of Coatings Before and After Oven Test

A-286 COUPONS (650°C)

INCONEL X-750 COUPONS (540°C)

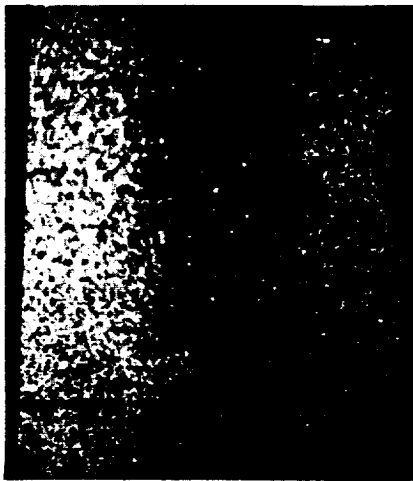
Fig. V.1 Photographs of Surfaces After Test at 1000 Cycles at 290° C (Test No. 1)

MI284 ON FOIL IOX

Cr<sub>3</sub>C<sub>2</sub> ON JOURNAL IOX

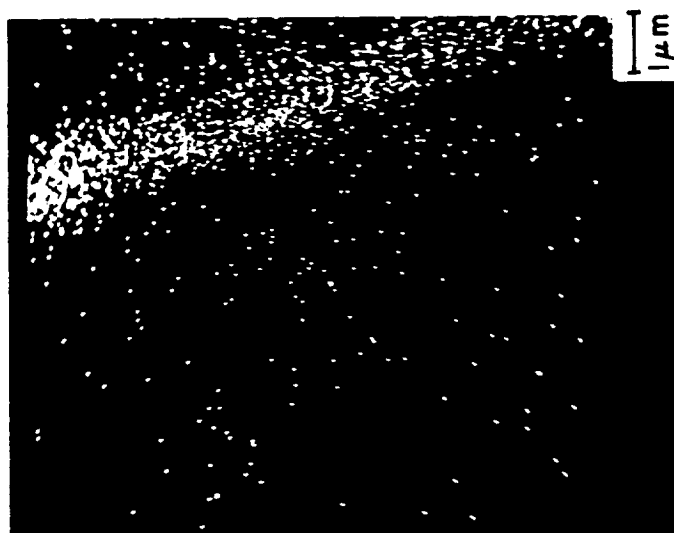
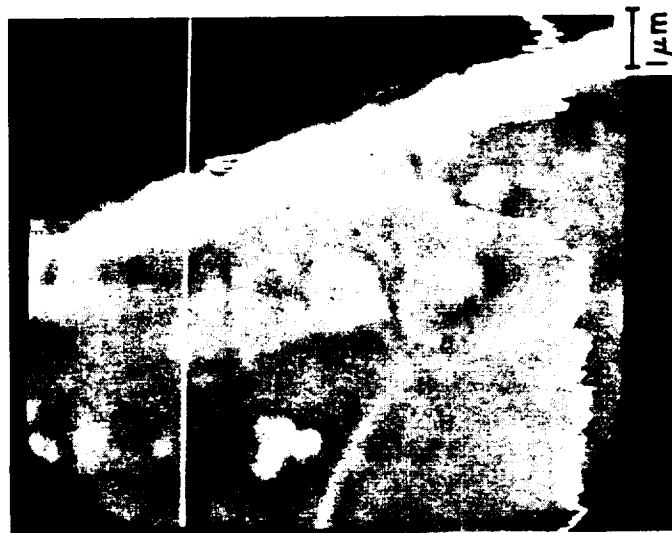
Fig. V.12 SEM Micrographs of the Cross Section of Sputtered Silicon Nitride Foil

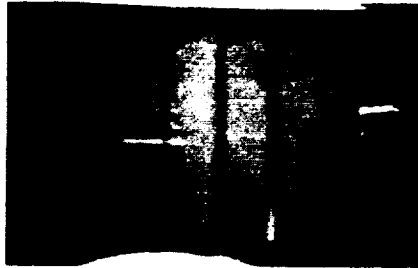
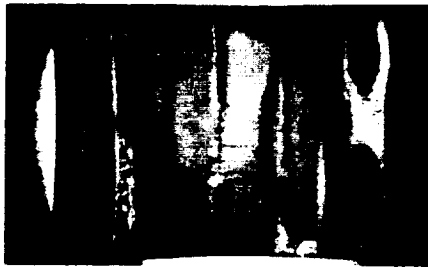
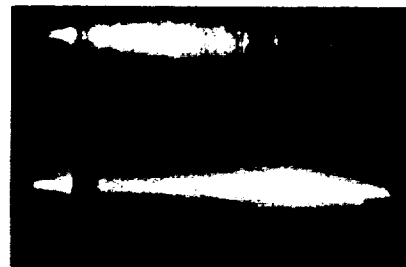
KAMAN DES ON FOIL AFTER  
500 CYCLES AT 650°C  
AND 500 CYCLES AT RT

KAMAN DES ON FOIL AFTER  
1000 CYCLES AT 650°C  
AND 1000 CYCLES AT RT

KAMAN DES ON JOURNAL  
AFTER 1000 CYCLES AT  
650°C AND 1000 CYCLES  
AT RT

| Test No. | Coating Combination | Foil and Journal Coatings | Max. Test Temp. | Breakaway Friction Coefficient | | | | | | Surface Roughness of Journal $\mu m$ (u in.) | | Results |
|---|---|---|---|---|---|---|---|---|---|---|---|---|
| 21** | None Assigned | Kaman DES | 650°C | S <sup>1</sup> | .31 | .32 | .51 | .33 | .48 | 0.33<br>(13) | 0.36<br>(14) | 500 cyc. at HT-Journal and foil lightly polished, some brown powder on foil. 500 cyc. at RT-Journal has three fine scratches and some bare metal showing on foil. 500 cyc. at HT and 500 cyc. at RT-very fine scratches on journal filled with loose powder. Foil has some bare metal with microscopic patches and shiny appearance. Rated-successful. |

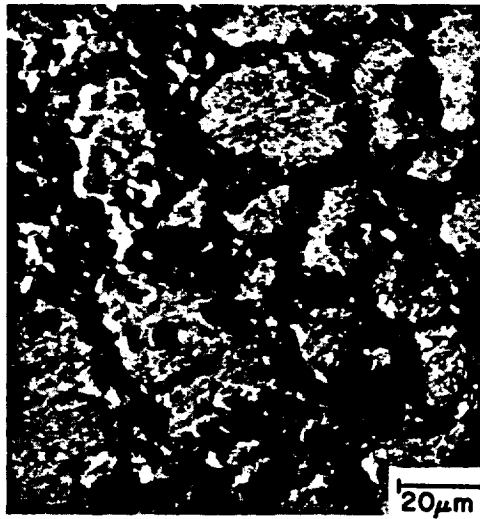
Fig. V.14 SEM Micrographs and Diffractographs of Kaman DES Coated Inconel X-750, Heavily Worn Area (Test No. 21)

It was concluded from the analysis that the patches of the remaining coating found on the heavily loaded area are rich in chromium and the worn surface is NiO which resulted from Inconel surface oxidation during testing. The structure of the patches almost gives the impression that they coincide with the grain boundaries. It is hypothesized that, during the coating process of Kaman DES, first the chromium from the slurry is bonded to grain boundaries, and the chromium deposited later is oxidized with liberated oxygen available in the slurry and, as a result,  $\text{Cr}_2\text{O}_3$  is deposited on the surface. As indicated earlier, the bulk of Kaman DES coating is essentially  $\text{Cr}_2\text{O}_3$ . After testing, the later deposited  $\text{Cr}_2\text{O}_3$  is all worn away and the initially deposited chromium is still present on the surface. This may mean that the initially

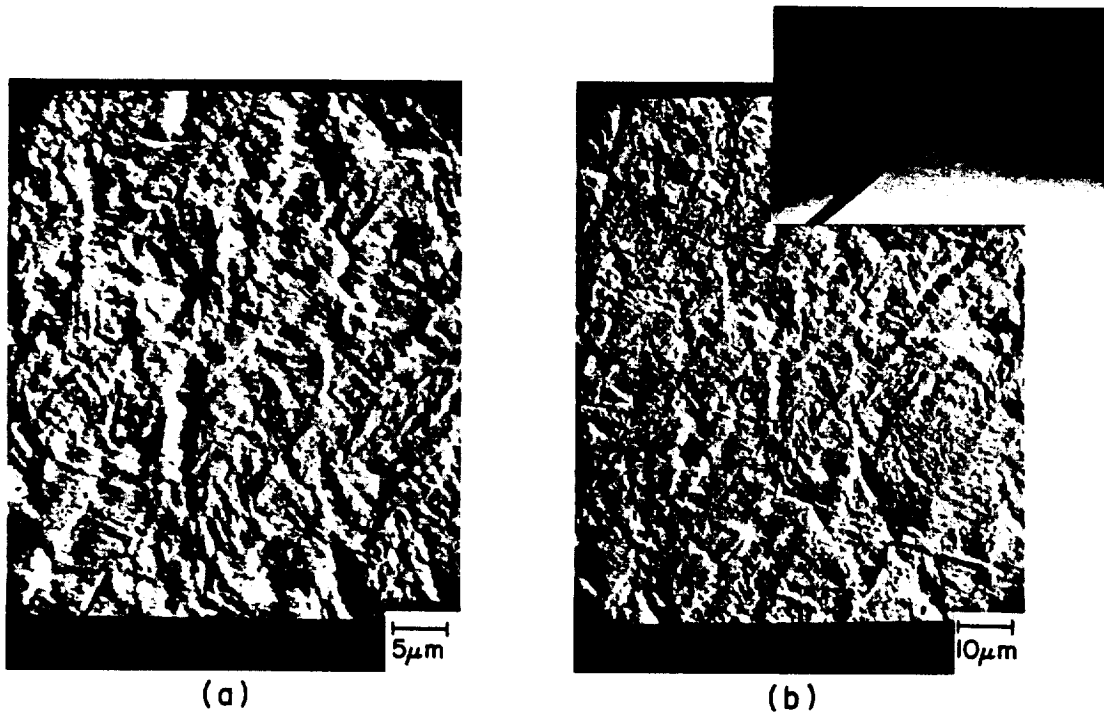
Figure D.1 shows the surface morphology of a heat heated Inconel X-750 coupon (uncoated) for later comparisons. Figure D.2 shows the surface appearance of sputtered TiC coating (as received). In comparing Figure D.2 with Figure D.1, it was believed that the coating followed the topography of the substrate. The coating was believed to be dense and did not have any cracks. There were many particles on the surface. Examination of the surface showed that there were no foreign particles present on the coating. The elemental analysis (X-REDA) of the particles and rest of the coating showed that all of the coating is made of Titanium carbide.

Fig. D.1 Typical SEM Micrographs and Diffractogram of Heat Treated Inconel X-750

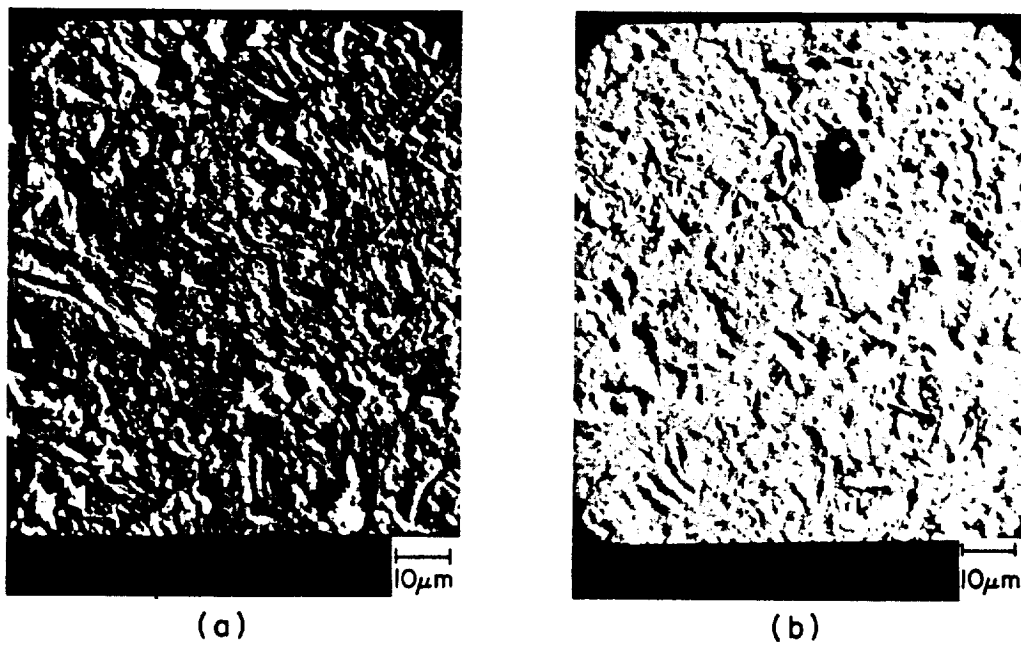
Fig. D.2 Typical SEM Micrographs of Sputtered TiC on Inconel Base (as received)

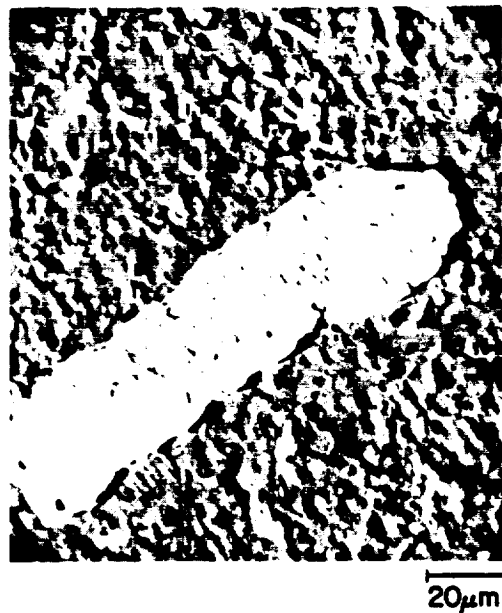
Fig. D.3 Typical SEM Micrograph of Sputtered TiC  
(as received) with a Man Made Scratch

Figure D.3 shows the surface appearance of the sputtered TiC coating after exposed to high temperature. The scratch in Figure D.3(a) was probably done in handling the coupon. The particle density on this coupon was higher and their size was statistically larger than before oven coupon. It was again believed that the particles were an integral part of the coating. X-REDA analysis of the particles and rest of the coating showed that the coating was composed of Titanium carbide and the substrate underneath has elements expected in Inconel (primary elements Ni, Cr, Fe and Ti). The analysis of the particles and the substrate underneath showed that they had elements such as Al, Si, S, Fe, P, and very little Ti and Cr. Some particles had considerable Ni and others had very little. From this observation, it was postulated that microspots

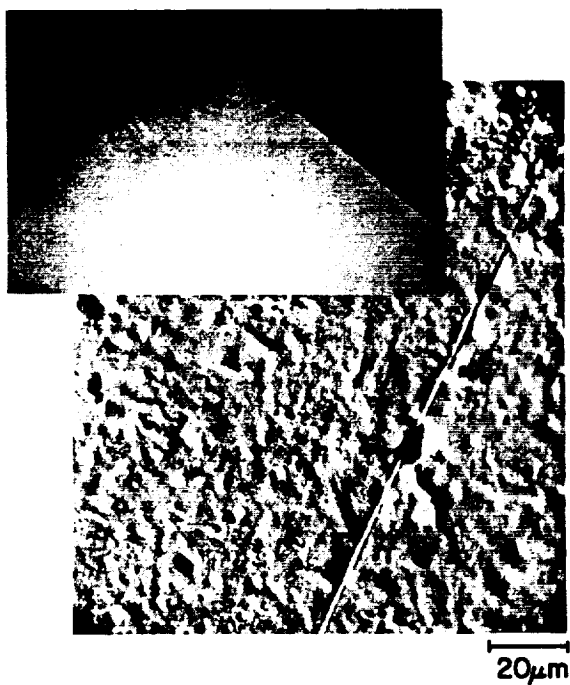
Fig. D.4 Typical SEM Micrographs and Diffractogram of Sputtered TiC  
on Inconel Base (After Oven)

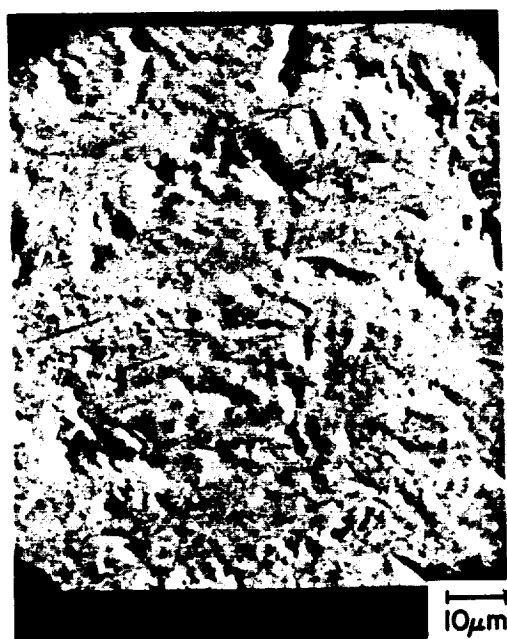
Figure D.5 shows the surface appearance of the  $\text{Si}_3\text{N}_4$  sputtered coating. The coating appeared to be dense and had no cracks. The valleys on the surface came from the substrate topography (Figure D.1). Portion of  $\text{Si}_3\text{N}_4$  coating was oxidized during oven test. Figure D.6 shows non-oxidized and oxidized area of the coating after oven test. The coating after oven test looked about the same as before exposure. Oxide layer on the coating after oven test formed no shadow in tilting the specimen with respect to light in SEM study which implies that it had practically no thickness. The layer could be easily scrapped off and  $\text{Si}_3\text{N}_4$  color appeared underneath. X-REDA analysis confirmed that the coating was composed of Si compounds.

Fig. D.5 SEM Micrograph of Sputtered  $\text{Si}_3\text{N}_4$  on Inconel Base (as received)

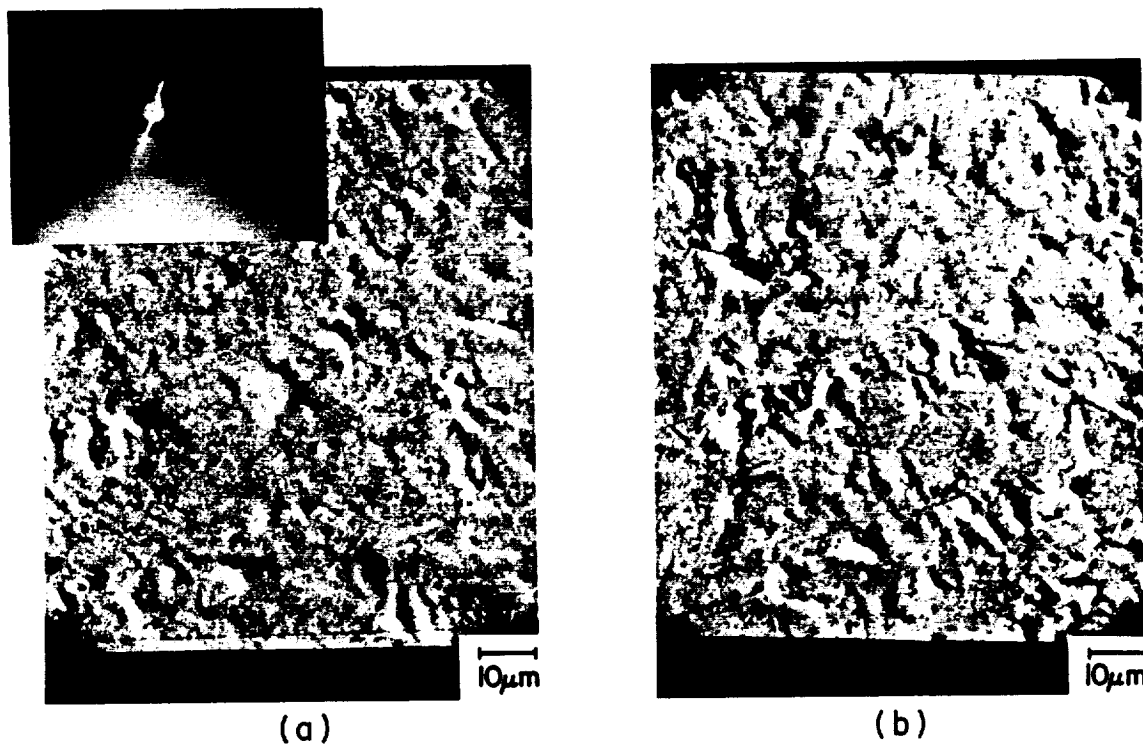
Fig. D.6 SEM Micrographs and Diffractogram of Sputtered  $\text{Si}_3\text{N}_4$  on Inconel Base (after oven)

The composition and properties of sputtered coatings depend on sputtering parameters. Reflection electron diffraction analysis of some of the promising coatings was carried out to evaluate their chemical composition. In case of sputtered  $\text{Al}_2\text{O}_3$ , it was suspected that the vendor had not applied an adequate thickness. The analysis was carried out to see if there was any  $\text{Al}_2\text{O}_3$  at all on the surface. The samples examined had gone through oven test and they were: TiC sputtered on foil,  $\text{Si}_3\text{N}_4$  sputtered on foil, HL-800 on foil after oven,  $\text{Al}_2\text{O}_3$  sputtered on foil before oven, Inconel base metal as a control. The following specimens were analyzed with X-Ray Diffraction technique:  $\text{Cr}_2\text{O}_3$  sputtered on foil and Kaman DES on foil. The ED examination of TiC revealed that coating oxidized to  $\text{TiO}_2$  during oven test (for diffractogram, see Figure D.4a). The diffraction patterns of  $\text{Si}_3\text{N}_4$  and  $\text{SiO}_2$  are very close and it could not be resolved if the coating was  $\text{Si}_3\text{N}_4$ ,  $\text{SiO}_2$  or both (for pattern, see Figure D.6a).

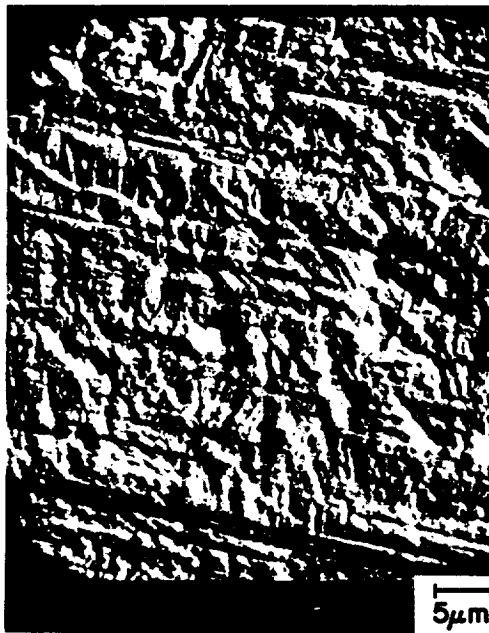
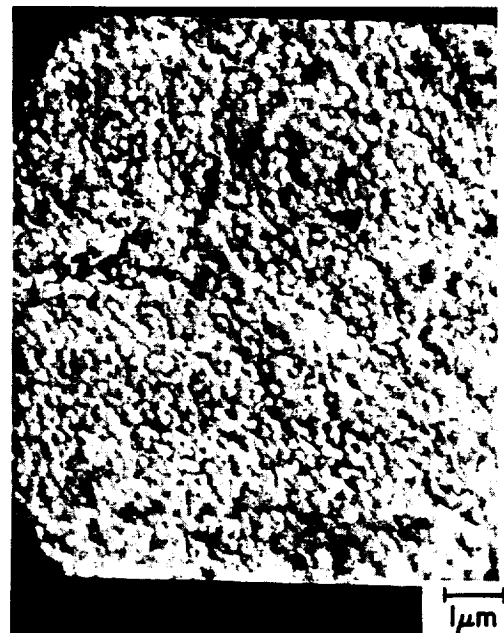
Fig. D.7 Typical SEM Micrographs of Sputtered Cr<sub>2</sub>O<sub>3</sub> on Inconel Base (as received)

Figure D.7 shows the surface appearance of  $\text{Cr}_2\text{O}_3$ , sputtered coating on Inconel base. Comparisons, with uncoated Inconel X750 surface (Figure D.1), show that the coating follows the surface texture. The photograph taken at a magnification of 10,000 X, to study the surface morphology (Figure D.7b), shows that the coating has nodular growth. Nodules grow within columnar structure and project to the surface with domes. The structure looks like peelings of an orange or a cauliflower. Similar results have been reported by Spalvins [18,19]. Spalvins postulated that the nodules grow from the nucleation sites present on the substrate. He concluded that the nodules have undesirable effects on mechanical properties; cracks are initiated at the nodules when the coating is stressed by mechanical forces. It is felt that evidence of such growth is to be expected at higher magnifications ( $\times 10,000$ ) although further tests should be carried out to establish if the

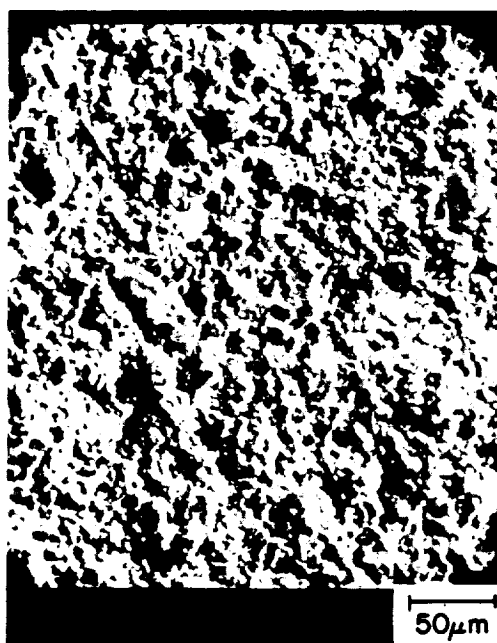
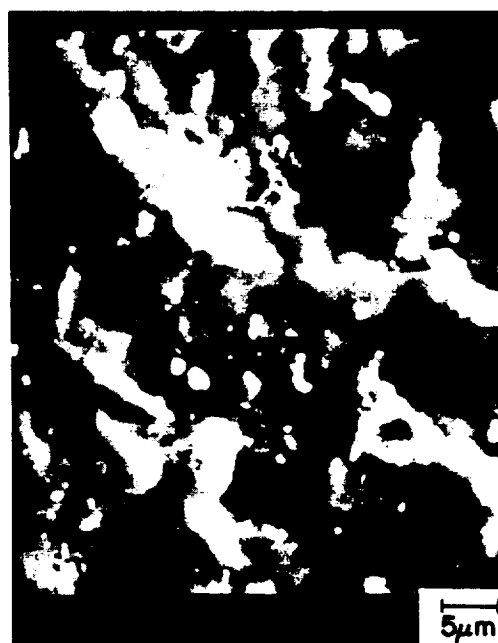
Fig. D.13 Typical SEM Micrographs of HL-800 on Inconel Base  
(as received)

Figure D.13 shows the surface appearance of the HL-800 coating. X-REDA analysis showed that small particles were CdO coated with sillicate. CdO particles were quite randomly mixed with graphite and were bonded with sillicate.

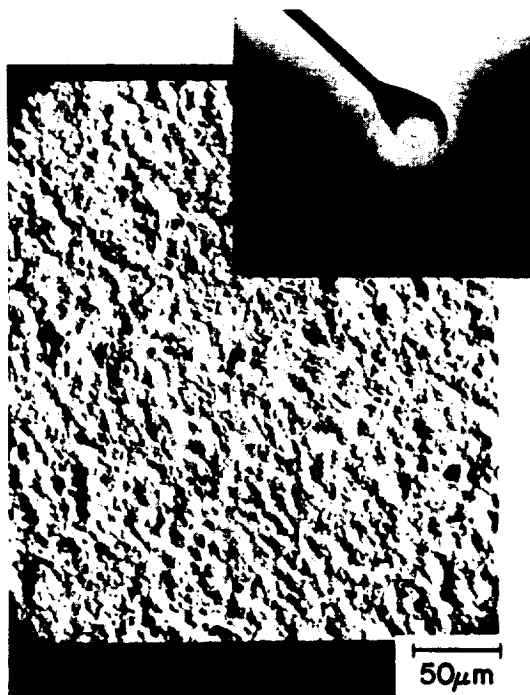
Fig. D.14 Typical SEM Micrograph and Diffractogram of  
HL-800 on Inconel Base (after oven)

Figure D.14 shows the coating after oven test. Elemental analysis and visual examination of the coating showed the composition of the coating was the same as that of the coating before oven tests except that the graphite content is less. The coating looked intact. CdO particles were not as prominent. They may have reacted with other components in the coating.
